# Manhole Inspection Summary

Manhole # S17Y\_\_006MH

Insp Date: **7/14/09 1:14 PM**

**Location** Address: **1600 DESOTO RD** Cross Street: **DESOTO PARK**

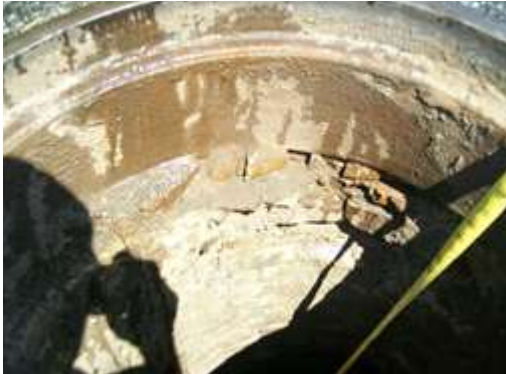
Defect 2

**Frame** Offset: **4** (in.) Condition: ☐ Sound ☐ Cracked ☒ **Leaks**

FRAME LEAKS & IS OFFSET

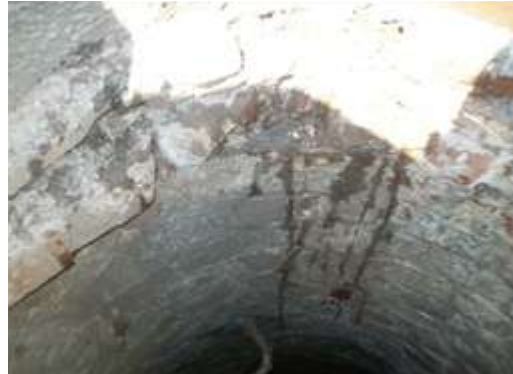
Defect 1

**Chimney / Frame Adjustment** ☒ Exists Material: **Brick** ☐ Parged Height: **5** (in.)  
Condition: ☐ Sound ☐ Cracked ☐ Root Intrusion ☒ **Loose Brick** ☐ Deteriorated  
Infiltration: ☒ None ☐ Joint ☐ Cracks ☐ Mortar ☐ Roots ☐ Wall

LOOSE CHIMNEY BRICKS

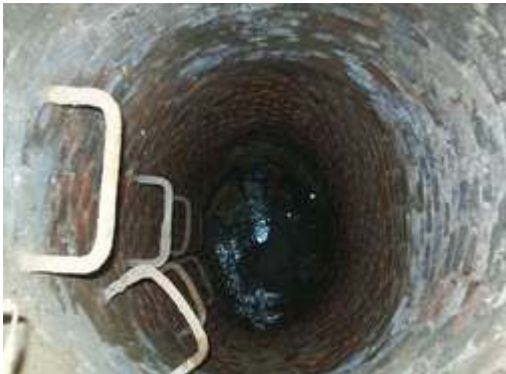
Defect 3

**Steps** Count: **11** Missing: **1** ☒ **Corroded**

**Surcharge** ☒ **Evidence Of Surcharge** Depth: **5** (ft.) ☐ Active Surcharge Present

missing/corroded steps; surcharge  
evidence (prior to cleaning)

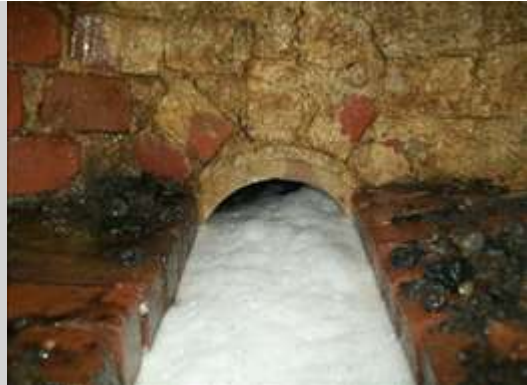
12 O'Clock Outflow

8 in. Circular Gravity Sewer  
Pipe Out @ 12 O'Clock

Pipe Height: **8.4** (in.) Rod and Bar (Angled)  
Pipe Material: **Clay** ☐ Pipe Lined  
Invert Depth: **17.42** (ft.) Flow Characteristics: **Slow**  
Deposits: ☒ None ☐ Mud ☐ Sludge ☐ Debris ☐ Grease  
Silt Depth: **0** (in.) Deposits Extent:  
Infiltration: **None** Pipe Seal Cond: **Sound**

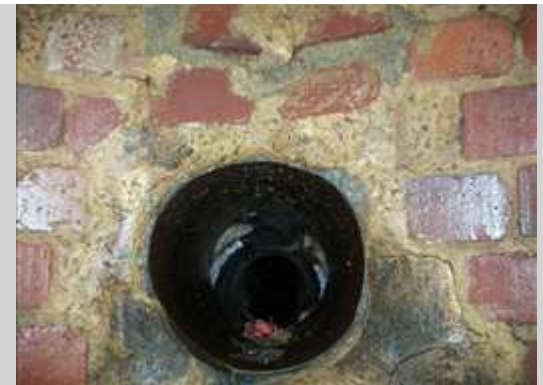
6 O'Clock Inflow

8 in. Circular Gravity Sewer  
Pipe In @ 6 O'Clock

Pipe Height: **10.8** (in.) Rod and Bar (Angled)  
Pipe Material: **Clay** ☐ Pipe Lined  
Invert Depth: **9.57** (ft.) Flow Characteristics: **Slow**  
Deposits: ☒ None ☐ Mud ☐ Sludge ☐ Debris ☐ Grease  
Silt Depth: **0** (in.) Deposits Extent:  
Infiltration: **None** Pipe Seal Cond: **Sound**

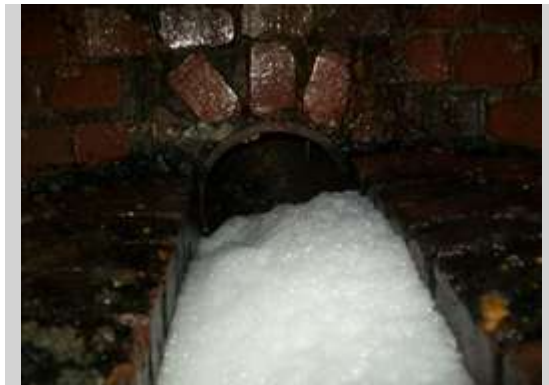
Drop In @ 6 O'Clock

Drop: **Outside**

Angled: Reading: **16.07** (ft.)

Inv Depth: **16.39** (ft.)

Drop Condition: **Open**
